**Flood Control Project Maintenance  
Levee Inspections**

**Maintenance Issue Types Only, Levee Inspection Report By Mile - Spring 2020**

**Reclamation District No. 0349 Sutter Island**

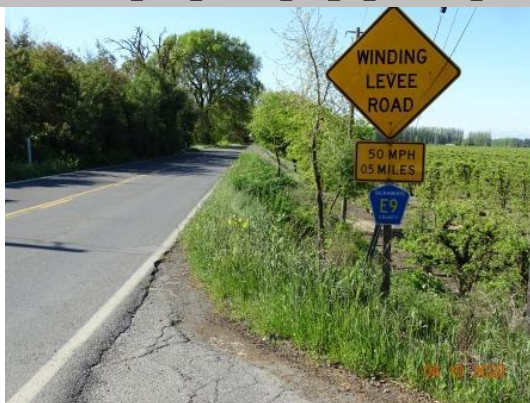
Photo 1 of 1 : SP\_2020\_RD0349\_204\_11\_20200410\_00033.jpg

LM Start	0.01	Rating **	U	Issue No.	11
LM End	0.37	Issue Type +	Ma	Location *	LS
Category	Earthen Levee			GPS Latitude/Longitude	
				Start	End
Item	Vegetation			38.327056 °	38.321919 °
				-121.577020 °	-121.578396 °
DWR ID	DWR_RD0349_01_f_2019_11				
Comment Code					
V1 : Control annual grass and weeds on the levee slopes and easements.					
Inspector Comment

View looking downstream at annual vegetation on the landside slope (Spring 2020).

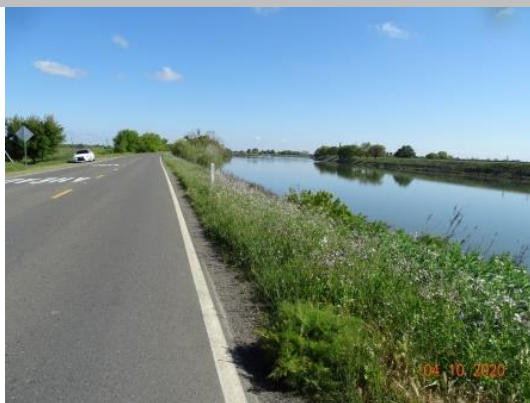
Photo 1 of 1 : SP\_2020\_RD0349\_204\_23\_20200410\_00034.jpg

LM Start	0.01	Rating **	U	Issue No.	23
LM End	0.50	Issue Type +	Ma	Location *	WS
Category	Earthen Levee			GPS Latitude/Longitude	
				Start	End
Item	Vegetation			38.327038 °	38.320101 °
				-121.576922 °	-121.578619 °
DWR ID	DWR_RD0349_01_s_2020_23				
Comment Code					
V1 : Control annual grass and weeds on the levee slopes and easements.					
Inspector Comment

View looking upstream at annual vegetation on the waterside slope (Spring 2020).

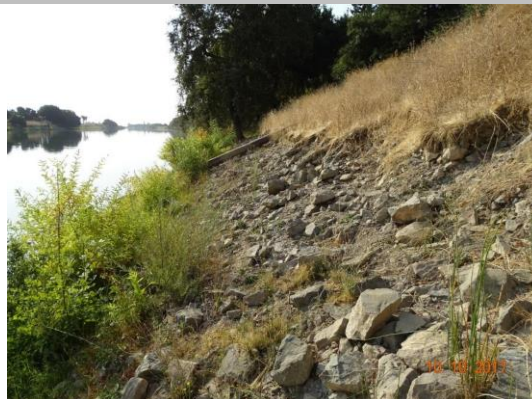
Photo 1 of 1 : SP\_2020\_RD0349\_204\_15\_20200304\_00004.jpg

LM Start	1.00	Rating **	M	Issue No.	15
LM End	1.06	Issue Type +	Ma	Location *	WS
Category	Earthen Levee			GPS Latitude/Longitude	
				Start	End
Item	Erosion / Bank Caving			38.312911 °	38.312131 °
				-121.578528 °	-121.578292 °
DWR ID	LMA-145				
Comment Code					
E2 : Schedule repair of erosion site prior to the next inspection.					
Inspector Comment					
<p>This was a 2017 Storm Damage site.</p> <p>Approximately 296 linear-feet of eroded area. Erosion commences at approximately 3/4 of the way down the slope from the crown and extends into the rip rap. Some rip rap has been pulled off in this section.</p> <p>Site ID No:318</p> <p>Site Designation:LMA-145</p> <p>4/10/2020 Field Notes:</p> <p>Vegetation too thick to view from the crown. Boat survey will provide better view.</p>

Waterside erosion at LM 1.02.

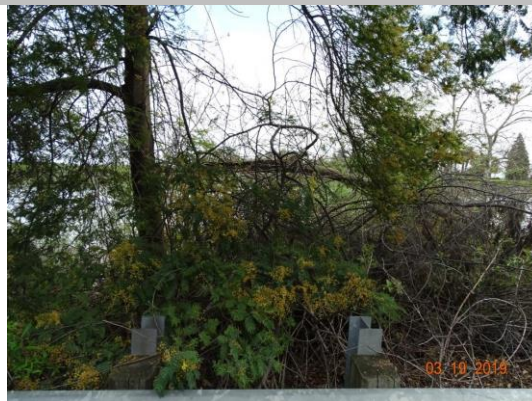
Photo 1 of 1 : SP\_2020\_RD0349\_204\_16\_20200304\_00005.jpg

View of thick trees on the waterside slope (Spring 2019).

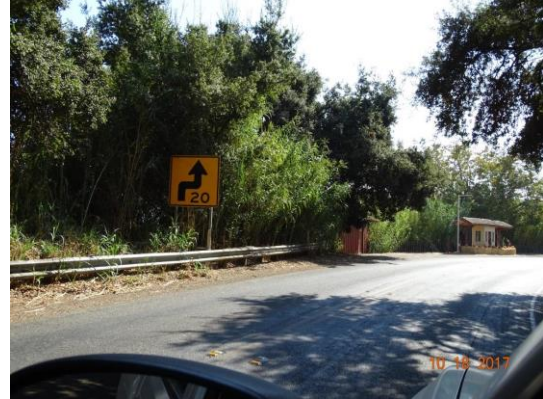
Photo 1 of 1 : SP\_2020\_RD0349\_204\_34\_20200304\_00013.jpg

View of arundo on the waterside of levee

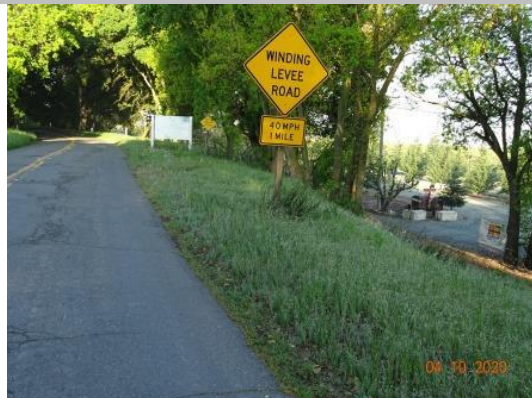
Photo 1 of 1 : SP\_2020\_RD0349\_205\_22\_20200410\_00115.jpg

View looking downstream at annual vegetation on the landside slope (Spring 2020).

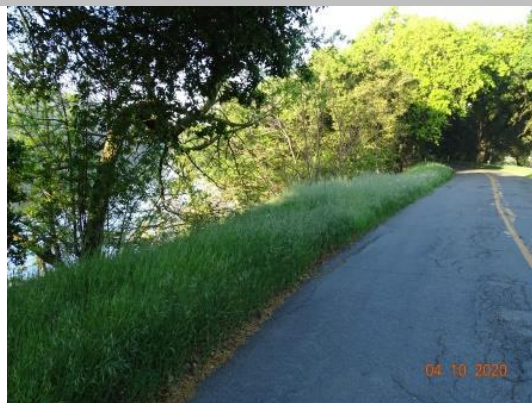
Photo 1 of 1 : SP\_2020\_RD0349\_205\_36\_20200410\_00114.jpg

LM Start	0.04	Rating **	M	Issue No.	36
LM End	3.35	Issue Type +	Ma	Location *	WS
Category	Earthen Levee			GPS Latitude/Longitude	
				Start	End
Item	Vegetation			38.304864 °	38.262889 °
				-121.575399 °	-121.589275 °
DWR ID	DWR_RD0349_02_s_2020_36				
Comment Code					
V1 : Control annual grass and weeds on the levee slopes and easements.					
Inspector Comment

View looking downstream at annual vegetation on the waterside slope (Spring 2020).

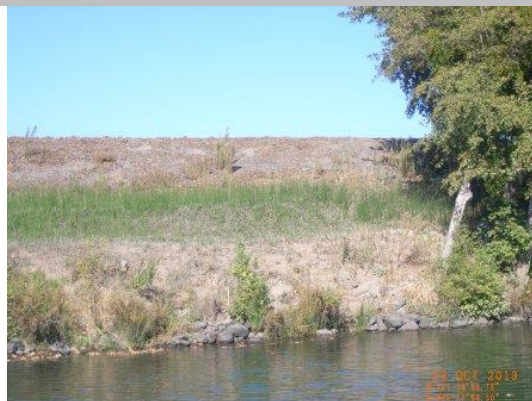
Photo 1 of 1 : SP\_2020\_RD0349\_205\_28\_20200304\_00011.jpg

LM Start	0.60	Rating **	M	Issue No.	28
LM End	0.72	Issue Type +	Ma	Location *	WS
Category	Supplemental			GPS Latitude/Longitude	
				Start	End
Item	2017 USACE Erosion Survey			38.298897 °	38.297384 °
				-121.581571 °	-121.582176 °
DWR ID	DWR_RD0349_02_f_2018_28				
Comment Code					
Inspector Comment					
2017 Site ID: STM 25.5 R					
Status: Eroding					
2017 Field Notes: No observed change.					
Site History: 2010 - Small maintenance, erosion into the toe. 2011 - Minor new erosion at toe. 2015 - Minor new erosion at toe, new tree pop-out. 2016 - Fresh scarp at downstream end.

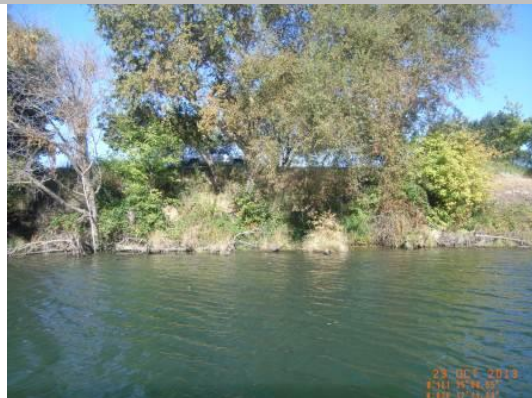
Photo 1 of 1 : SP\_2020\_RD0349\_205\_27\_20200304\_00010.jpg

Comment Code					
Inspector Comment					
2017 Site ID: STM 24.7 R					
Status: Critical					
2017 Field Notes: No observed change.					
Site History: 1997 - Erosion of very sandy levee behind large stand of riparian vegetation on top right bank. Dry ravel of sand. 1999 - Quarry waste rock was dumped down the levee slope; poor repair job; still eroding in places. Eroding at midslope off fabric. 2005 - Length revised, only the middle 150 - 200 ft are eroding. 2006 - Some rock/small material dumped down the bank but it is slowly unraveling. Upstream end is unraveling faster. Steep slope with poor gradation so fines are washing out. 2010 - Lots of overhanging trees and erosion pockets. 2011 - This site is upgraded to CRITICAL. Near vertical bank at the downstream end. New erosion at various locations throughout the site.

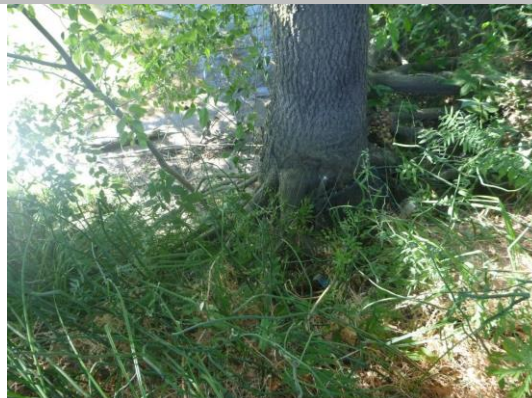
Photo 1 of 1 : SP\_2020\_RD0349\_205\_34\_20200304\_00016.jpg

LM Start	1.46	Rating **	M	Issue No.	34
LM End	1.46	Issue Type +	Ma	Location *	WS
Category	Earthen Levee			GPS Latitude/Longitude	
				Start	End
Item	Erosion / Bank Caving			38.286886 °	38.286861 °
				-121.584589 °	-121.584622 °
DWR ID	LMA-149				
Comment Code					
E2 : Schedule repair of erosion site prior to the next inspection.					
Inspector Comment					
This was a 2017 Storm Damage site. Approximately 12 linear feet of erosion/sloughing. The erosion area commences approximately halfway down the slope from the levee crown and extends to the waterside toe around existing trees. No rip rap is visible in this area. Site ID No:322 Site Designation:LMA-149 4/10/2020 Field Notes: Vegetation too thick to view from the crown. Boat survey will provide better view.

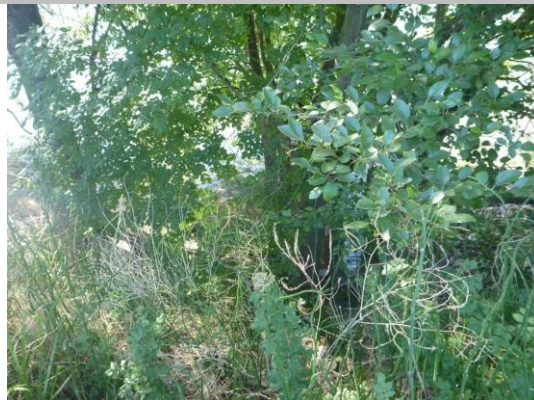
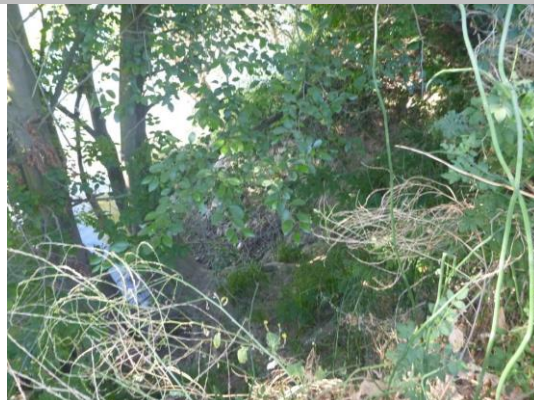
This was a 2017 Storm Damage site.  
Approximately 77 linear feet of erosion and scour. The erosion area commences approximately halfway down the slope from the levee crown and extends to the waterside toe around existing trees. No rip rap is visible in this area.  
Site ID No:323  
Site Designation:LMA-150  
4/10/2020 Field Notes:  
Vegetation too thick to view from the crown. Boat survey will provide better view.

E2 : Schedule repair of erosion site prior to the next inspection.

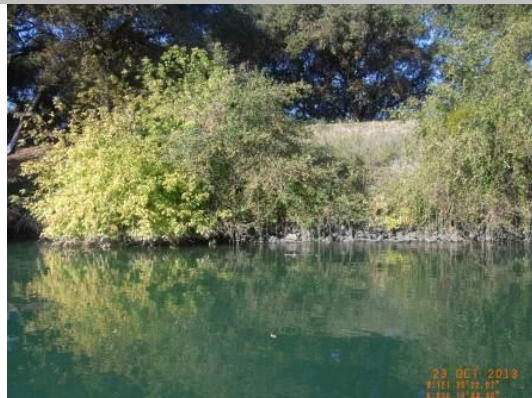
Photo 1 of 1 : SP\_2020\_RD0349\_205\_25\_20200304\_00008.jpg

LM Start	2.11	Rating **	A/W	Issue No.	25
LM End	2.14	Issue Type +	Ma	Location *	WS
Category	Supplemental			GPS Latitude/Longitude	
				Start	End
Item	2017 USACE Erosion Survey			38.279017 °	38.278597 °
				-121.589615 °	-121.589854 °
DWR ID	DWR_RD0349_02_f_2018_25				
Comment Code					
Inspector Comment					
2017 Site ID: STM 23.9 R					
Status: Eroding					
2017 Field Notes: No observed change.					
Site History: 1997 - Top right bank has retreated into the levee. Site is between two rock sites. 1999 - Downstream half of the reach repaired with rock. 2000 - Trees leaning into the water. 2010 - Site appears worse. 2011 - New erosion at the toe. 2013 - Short vertical sections observed at upstream end. 2015 - Minor new erosion.

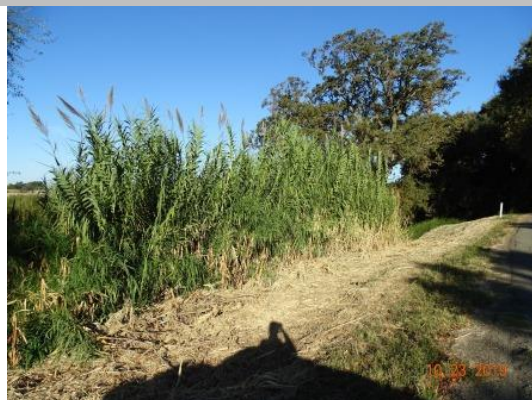
Photo 1 of 1 : SP\_2020\_RD0349\_205\_60\_20200304\_00038.jpg

LM Start	2.37	Rating **	U	Issue No.	60
LM End	2.39	Issue Type +	Ma	Location *	LS
Category	Earthen Levee			GPS Latitude/Longitude	
				Start	End
Item	Vegetation			38.275713 °	38.275435 °
				-121.591369 °	-121.591177 °
DWR ID	DWR_RD0349_02_f_2017_60				
Comment Code					
V2 : Remove the wild growth other than native grasses from the levee slopes.					
Inspector Comment					
Remove Arundo.

View looking upstream at arundo on the landside slope (Fall 2019).

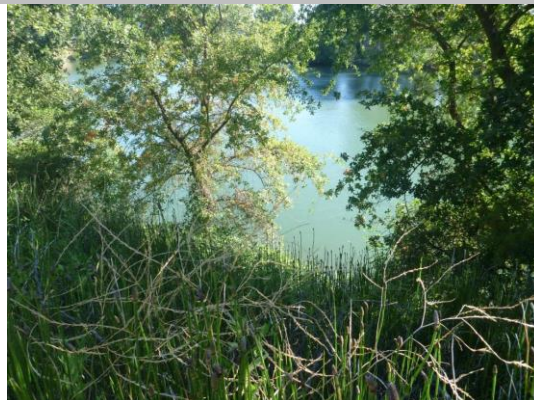
Photo 1 of 1 : SP\_2020\_RD0349\_205\_42\_20200304\_00027.jpg

LM Start	2.43	Rating **	M	Issue No.	42
LM End	2.44	Issue Type +	Ma	Location *	WS
Category	Earthen Levee			GPS Latitude/Longitude	
				Start	End
Item	Erosion / Bank Caving			38.275131 °	38.275036 °
				-121.590594 °	-121.590461 °
DWR ID	DWR_RD0349_02_s_2020_42				
Comment Code					
E2 : Schedule repair of erosion site prior to the next inspection.					
Inspector Comment					
This was a 2017 Storm Damage site. Approximately 51 linear feet of erosion. The erosion area commences approximately 3/4 of the way down the slope from the levee crown and extends to the waterside toe around existing trees. No rip rap is visible in this area. Site ID No:325 Site Designation:LMA-152 4/10/2020 Field Notes: Vegetation too thick to view from the crown. Boat survey will provide better view.

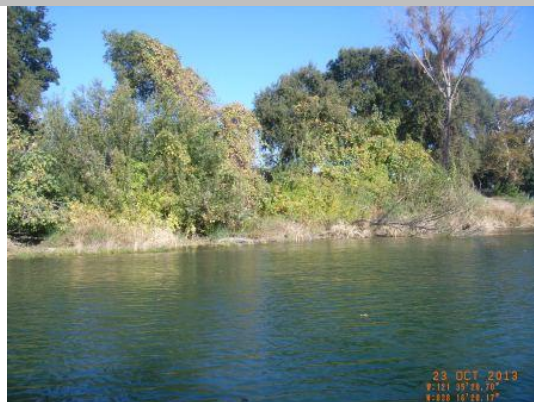
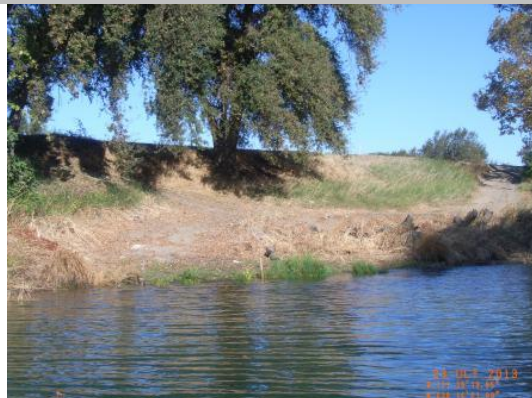
Photo 1 of 2 : SP\_2020\_RD0349\_205\_24\_20200304\_00006.jpg

LM Start	2.56	Rating **	A/W	Issue No.	24
LM End	2.69	Issue Type +	Ma	Location *	WS
Category	Supplemental			GPS Latitude/Longitude	
				Start	End
Item	2017 USACE Erosion Survey			38.273854 °	38.271998 °
				-121.588745 °	-121.589424 °
DWR ID	DWR_RD0349_02_f_2018_24				
Comment Code					
Inspector Comment					
2017 Site ID: STM 23.6 R					
Status: Eroding					
2017 Field Notes: Previously observed quarry stone at the downstream end is now gone. Significant erosion at upstream end. Fresh sedimentation on the downstream end.					
Site History: 2011 - Toe scour at the tidal zone. 2015 - New tree pop-out and minor new erosion. 2016 - New erosion at upstream end.

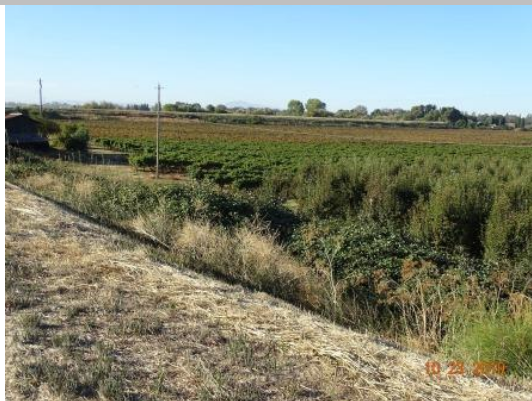
Photo 1 of 1 : SP\_2020\_RD0349\_205\_101\_20200304\_00056.jpg

View looking downstream at thick blackberries at the bottom of the landside slope (Fall 2019).

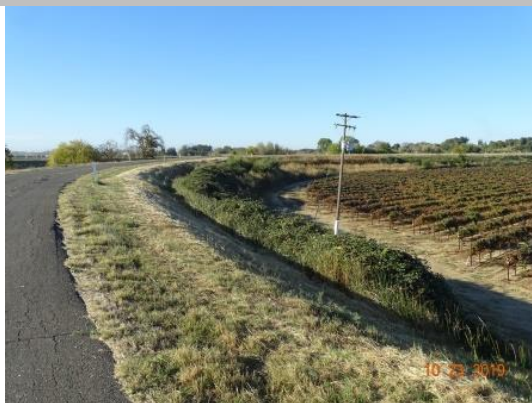
Photo 1 of 1 : SP\_2020\_RD0349\_205\_62\_20200304\_00040.jpg

LM Start	3.29	Rating **	U	Issue No.	62
LM End	3.60	Issue Type +	Ma	Location *	LS
Category	Earthen Levee			GPS Latitude/Longitude	
				Start	End
Item	Vegetation			38.263594 °	38.262449 °
				-121.588629 °	-121.593726 °
DWR ID	DWR_RD0349_02_f_2018_62				
Comment Code					
V2 : Remove the wild growth other than native grasses from the levee slopes.					
Inspector Comment					
Remove thick berry vines that completely block inspection and access to toe. Also control annual vegetation.

View looking downstream at thick blackberries on the bottom of the landside slope (Fall 2019).

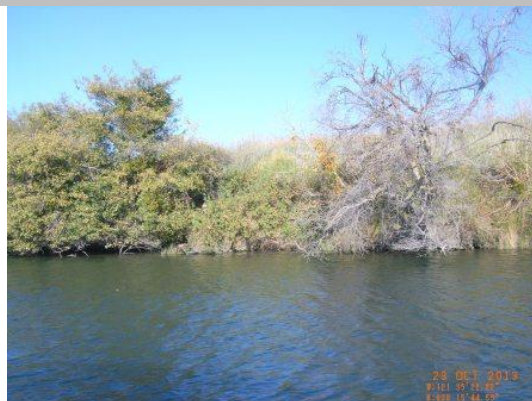
Photo 1 of 1 : SP\_2020\_RD0349\_205\_23\_20200304\_00005.jpg

LM Start	3.38	Rating **	M	Issue No.	23
LM End	3.49	Issue Type +	Ma	Location *	WS
Category	Supplemental			GPS Latitude/Longitude	
				Start	End
Item	2017 USACE Erosion Survey			38.262510 °	38.262533 °
				-121.589481 °	-121.591690 °
DWR ID	DWR_RD0349_02_f_2018_23				
Comment Code					
Inspector Comment					
2017 Site ID: STM 22.8 R					
Status: Eroding					
2017 Field Notes: No observed change.					
Site History: 2010 - Slumping sections on the lower bank, appears to be scouring around the trees. 2011 - Soil beach at toe.

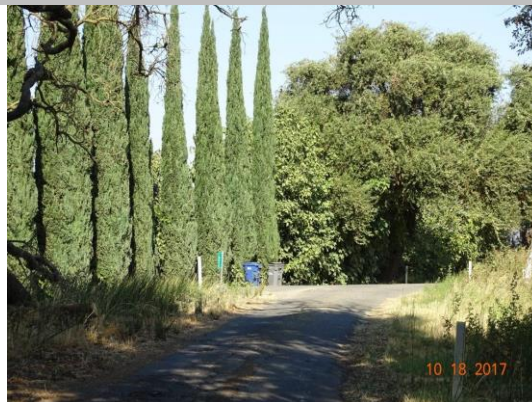
Photo 1 of 1 : SP\_2020\_RD0349\_205\_65\_20200304\_00043.jpg

View of fig trees and evergreen shrubs on the landside levee slope.

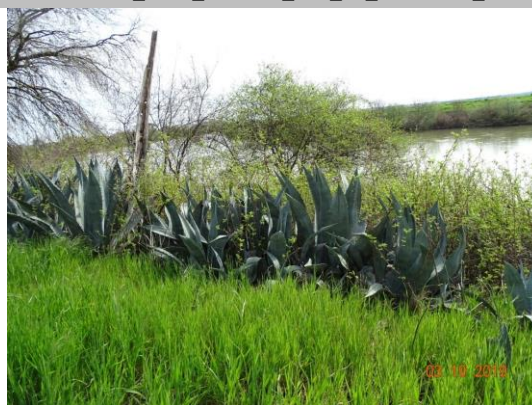
Photo 1 of 1 : SP\_2020\_RD0349\_205\_64\_20200304\_00042.jpg

View of cactus on the waterside shoulder (Spring 2019).

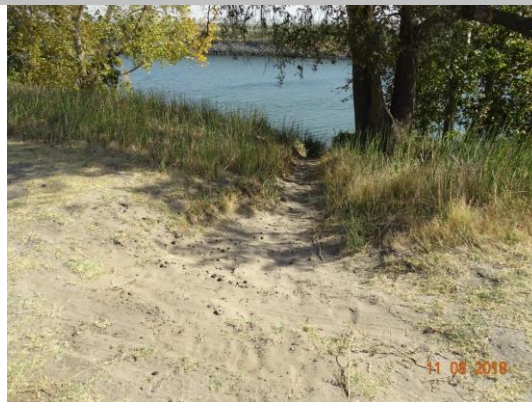
Photo 1 of 1 : SP\_2020\_RD0349\_205\_35\_20200304\_00018.jpg

LM Start	4.09	Rating **	M	Issue No.	35
LM End	4.09	Issue Type +	Ma	Location *	WS
Category	Earthen Levee			GPS Latitude/Longitude	
				Start	End
Item	Slope Stability			38.256065 °	38.256065 °
				-121.596305 °	-121.596305 °
DWR ID	DWR_RD0349_02_f_2018_35				
Comment Code					
S2 : Repair the levee slope damaged by foot traffic and prevent access where possible.					
Inspector Comment					
A foot path is beginning to dig into the waterside slope.

View of footpath going down the waterside slope (November 2018).

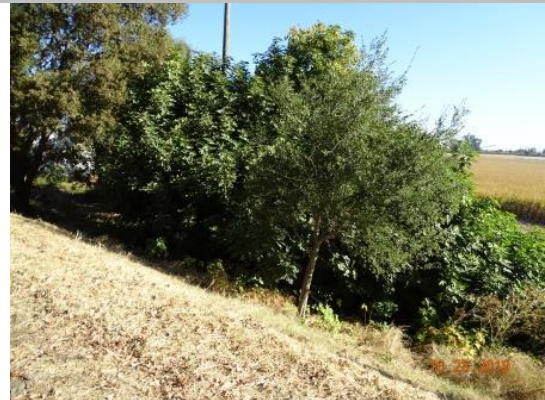
Photo 1 of 1 : SP\_2020\_RD0349\_206\_8\_20200304\_00001.jpg

View looking upstream at fig tree on the landside slope (Fall 2019).

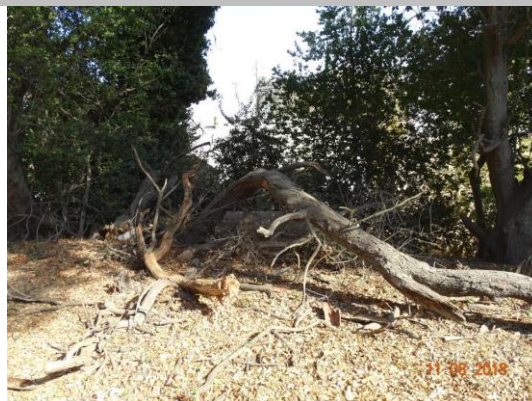
Photo 1 of 1 : SP\_2020\_RD0349\_206\_67\_20200304\_00022.jpg

View of down tree on the land side shoulder (November 2018).

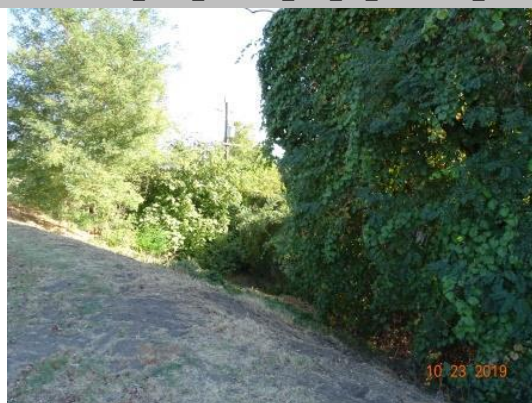
Photo 1 of 1 : SP\_2020\_RD0349\_206\_51\_20200304\_00015.jpg

LM Start	1.11	Rating **	U	Issue No.	51
LM End	1.13	Issue Type +	Ma	Location *	LS
Category	Earthen Levee			GPS Latitude/Longitude	
				Start	End
Item	Trim / Thin Trees			38.270452 °	38.270677 °
				-121.603587 °	-121.603572 °
DWR ID	DWR_RD0349_03_f_2017_51				
Comment Code					
T1 : Trim trees to at least five feet above ground level.					
Inspector Comment

View looking upstream at untrimmed trees on the landside slope (Fall 2019).

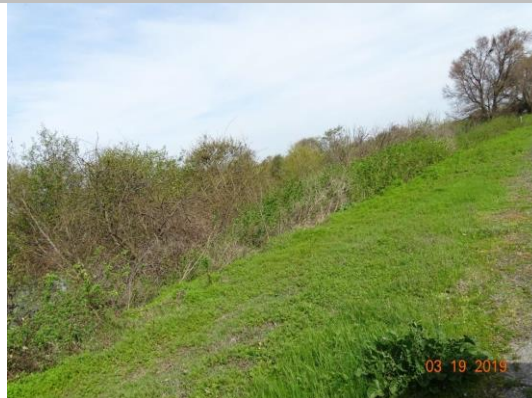
Photo 1 of 1 : SP\_2020\_RD0349\_206\_48\_20200304\_00013.jpg

View looking upstream at thick wild growth within 20 feet of the waterside shoulder (Spring 2019).

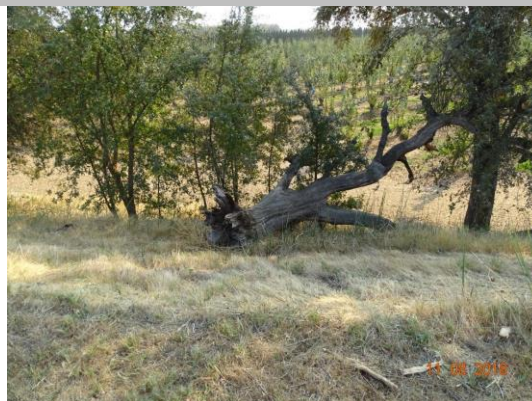
Photo 1 of 1 : SP\_2020\_RD0349\_206\_102\_20200304\_00032.jpg

View of tree on the landside slope (November 2018).

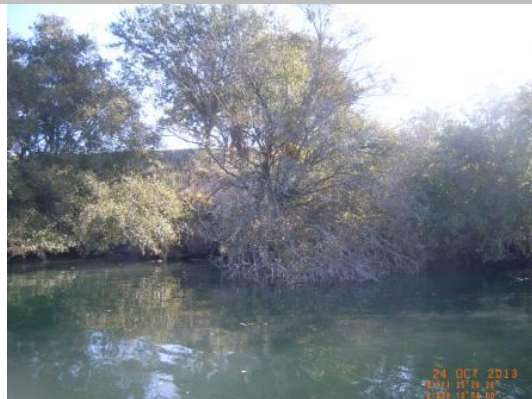
Photo 1 of 1 : SP\_2020\_RD0349\_206\_115\_20200304\_00037.jpg

Comment Code					
Inspector Comment					
2017 Site ID: STR 26.5 L					
Status: Eroding					
2017 Field Notes: There appears soil under geotech fabric that appears to be failing but hard to tell.					
Site History: 2002 - Original rock over geotextile is sliding off and the end is coming unraveled. 2003 - Some minor new erosion on the downstream end. 2004 - Site has gotten worse. Underlined geofabric is exposed. 2005 - Still looks bad with exposed geotextile fabric.					
2006 - Still have some new unraveling and exposed fabric. Site lengthened upstream. 2009 - Minimal new erosion. 2010 - geotextile fabric placed since last year, possible flood fight. 2012 - Exposed geotech style fabric, assume rock on top slid off. 2015 - Erosion pockets covered with plastic.

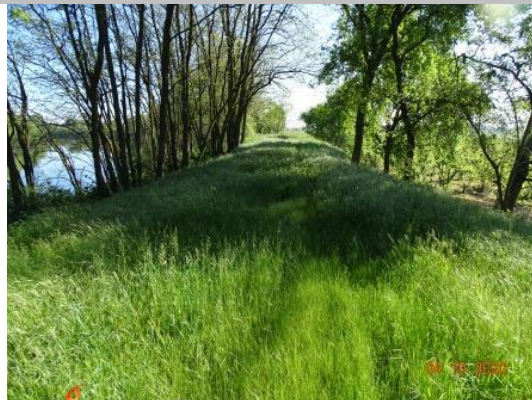
Photo 1 of 1 : SP\_2020\_RD0349\_206\_60\_20200410\_00104.jpg

LM Start	4.65	Rating **	U	Issue No.	60
LM End	5.57	Issue Type +	Ma	Location *	CR
Category	Earthen Levee			GPS Latitude/Longitude	
				Start	End
Item	Vegetation			38.314940 °	38.325943 °
				-121.591412 °	-121.584857 °
DWR ID	DWR_RD0349_03_s_2019_60				
Comment Code					
V9 : Keep the crown roadway free of vegetation.					
Inspector Comment

View looking upstream at vegetation on the crown (Spring 2020).

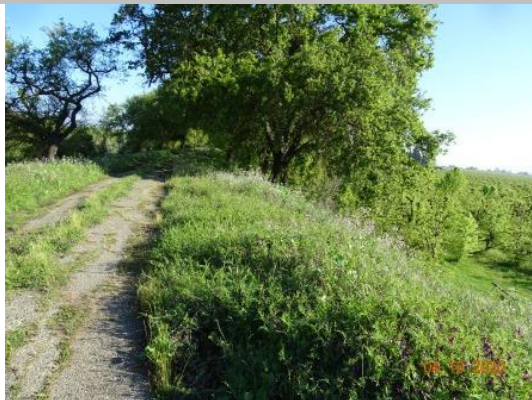
Photo 1 of 1 : SP\_2020\_RD0349\_206\_57\_20200410\_00103.jpg

View looking upstream at annual vegetation on the landside slope (Spring 2020).

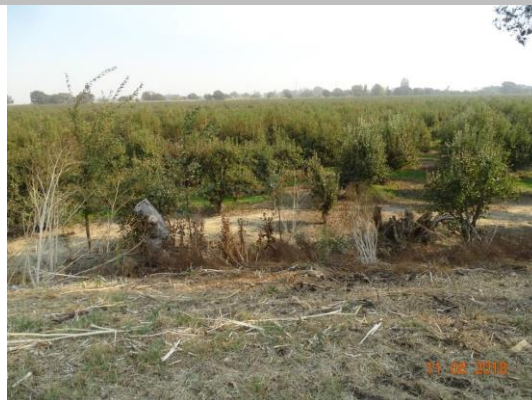
Photo 1 of 1 : SP\_2020\_RD0349\_206\_95\_20200304\_00030.jpg

View of down trees on the landside slope (November 2018).
